Manhole Inspection Summary

Manhole # S33C__027MH

Insp Date: **5/29/09 1:19 PM**

Location Address: **211 FRANKLIN ST (REAR)**

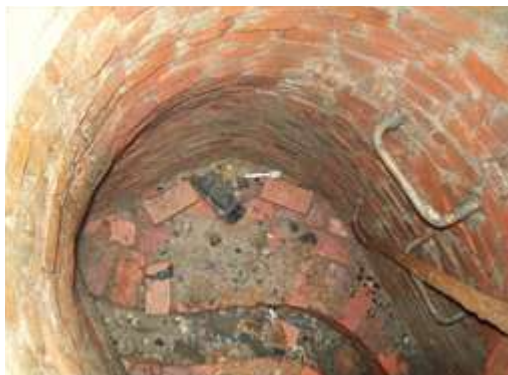
Defect 7

DEBRIS ON BENCH

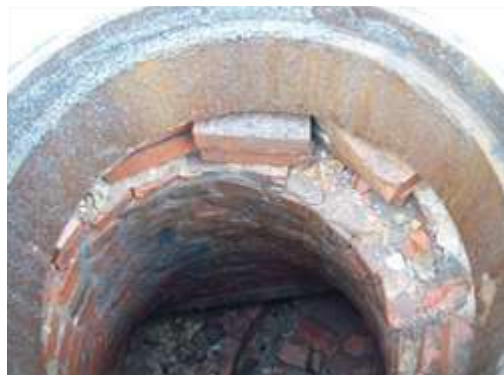
Defect 5

Condition: ☐ Sound ☒ **Cracked** ☐ Root Intrusion ☐ Deteriorated ☐ Leaks ☐ Debris

cracked on bench

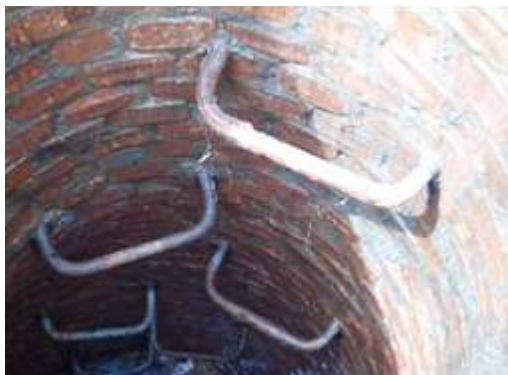
Defect 4

Condition: ☐ Sound ☐ Cracked ☐ Root Intrusion ☒ **Loose Brick** ☒ **Deteriorated**

deteriorated frame adjustment and frame offset

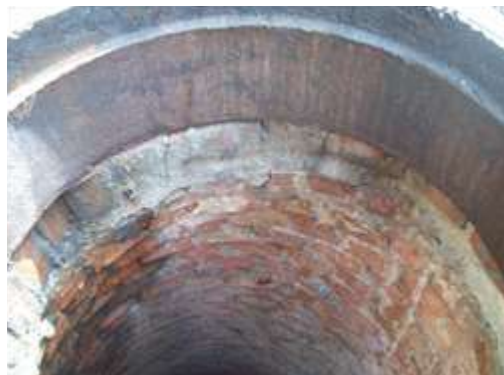
Defect 3

Steps Count: **4** Missing: **1** ☐ Corroded

CORRODED STEPS

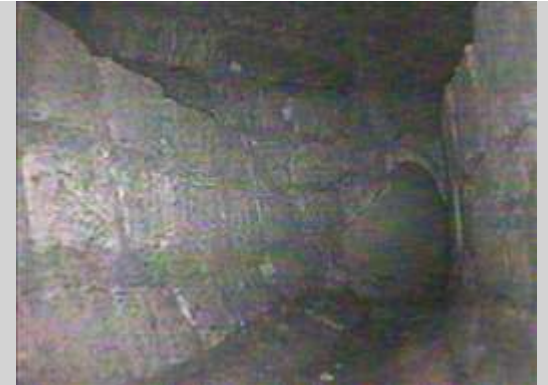
12 O'Clock Outflow

PIPE CRACKED.

Infiltration: **None** Pipe Seal Cond: **Cracked**

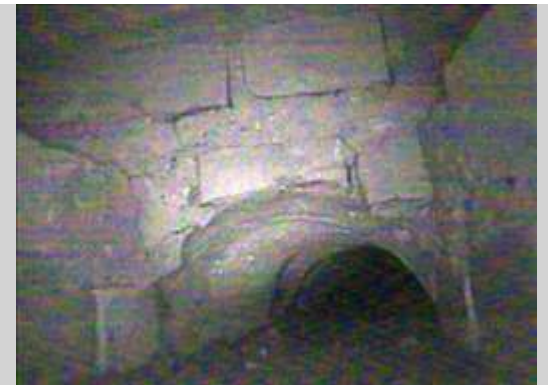
6 O'Clock Inflow

Deposits: ☐ None ☒ Mud ☒ Gravy ☒ Debris ☐ Grease

Silt Depth: **4** (in.) Deposits Extent: **Medium**

Infiltration: **None** Pipe Seal Cond: **Cracked**
